Site Name: Durham University Oriental Museum			
Site Code: DUROM	Conservator: Cathryn Harvey	Date: 22 Aug. 2017	Lab no: 2449
Small finds no: n/a	Context: n/a	Accession no: DUROM.1990.10	
<b>Object:</b> Arabian Dagger	Material: Cu alloy, Fe, wood	XR no: XR7080-XR7081, XR7169-XR7170

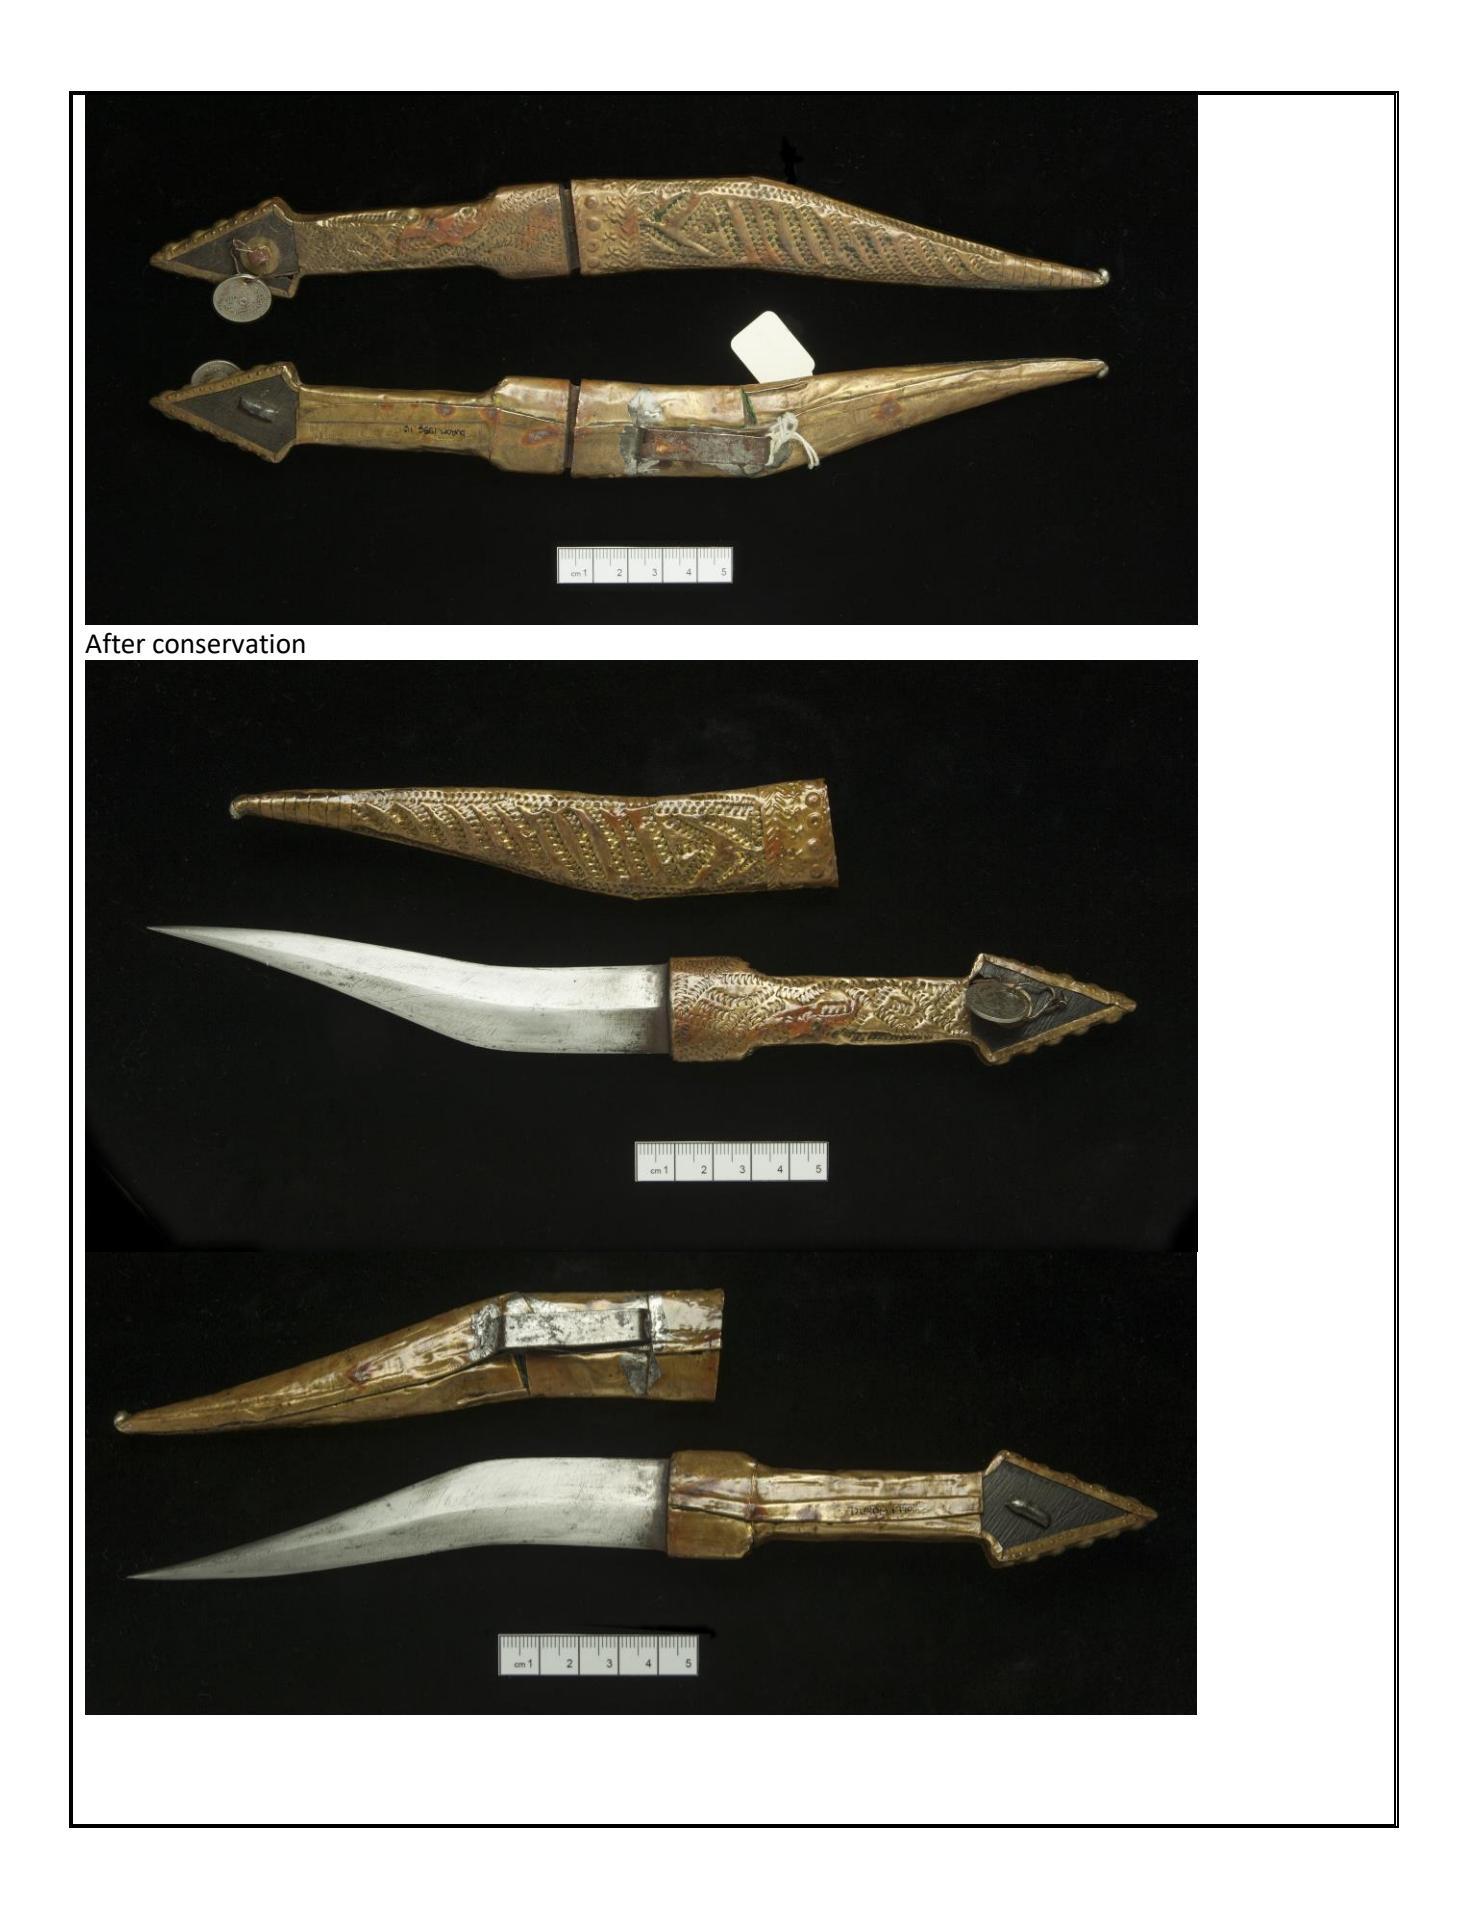
**Before Conservation**

**Description:** Arabian dagger with scabbard made of a stamped and beaten brass (copper-zinc alloy). The handle of the dagger is made of wood wrapped in the stamped and beaten brass, with a small nickel plated (probably Cu coin based on corrosion) coin with Arabic writing attached to the handle by a loop of wire (probably iron based). The coin dates to 1327 AH (Hijri calendar), which runs from 23 January 1909 to the 12 January 1910 in the Gregorian calendar. The dagger itself may be earlier than the coin suggests. The blade is curved, and is made of steel. The scabbard is made of the same stamped and beaten brass wrapped around two pieces of wood. Some kind of resin or adhesive may be holding the pieces of wood in place (causing corrosion). A belt loop is soldered to the back (this may be a later addition, as it appears to be iron based).
